Manhole Inspection Summary

Manhole # S31C__171MH

Insp Date: **9/22/09 12:49 PM**

Location Address: **SARATOGA ST**

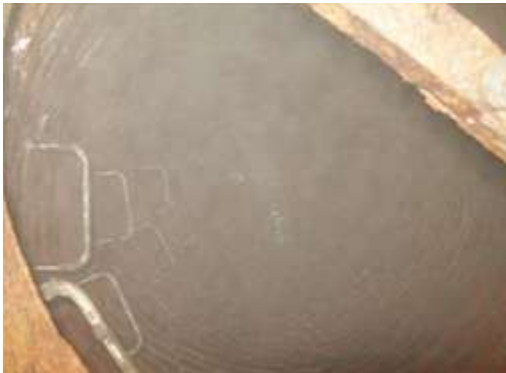
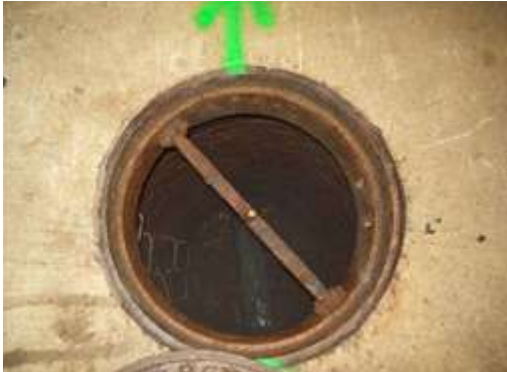
Too Much Steam - Cannot Have the Clear Top View

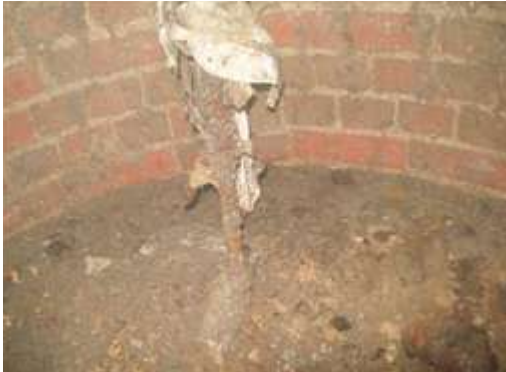
Defect 1

Condition: ☐ Sound ☐ Cracked ☐ Root Intrusion ☐ Deteriorated ☐ Leaks ☒ **Debris**

DEBRIS ON BENCH

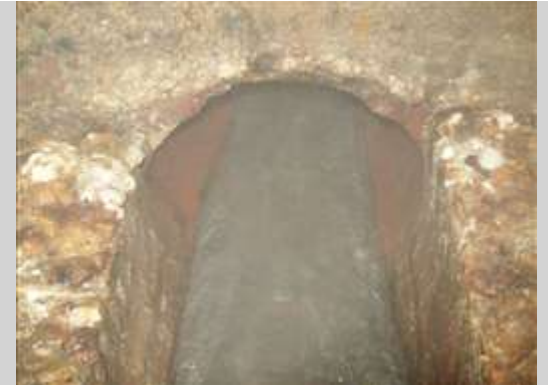
12 O'Clock Outflow

10 in. Circular Gravity Sewer
Pipe Out @ 12 O'Clock

Deposits: ☒ None ☐ Mud ☐ Sludge ☐ Debris ☐ Grease

Infiltration: **None** Pipe Seal Cond: **Sound**

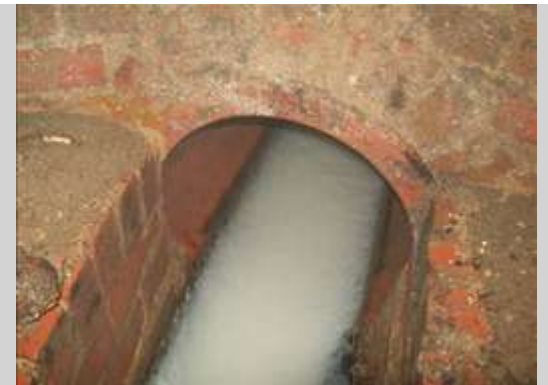
6 O'Clock Inflow

10 in. Circular Gravity Sewer
Pipe In @ 6 O'Clock

Deposits: ☒ None ☐ Mud ☐ Sludge ☐ Debris ☐ Grease

Infiltration: **None** Pipe Seal Cond: **Sound**
